SUBJECT Repair and Iron Forging Plant of
the Noril'sk Nickel Combine

[] Sketch of the Plant Layout of "RMZ"

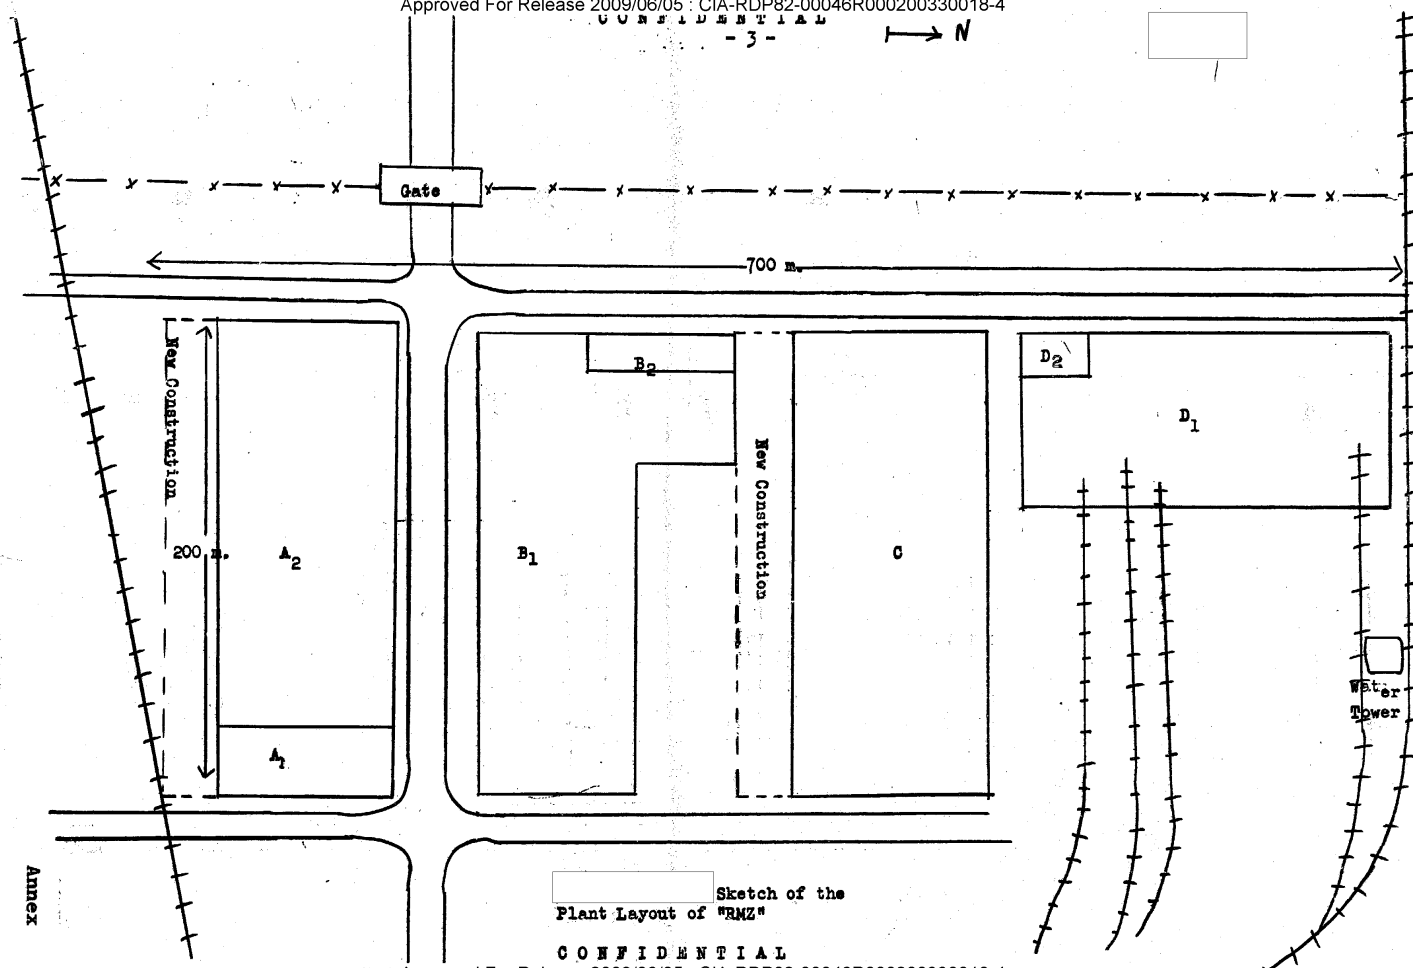
2. Building A was divided into two sections:

- a. Section A₁ was two storied; it had a kitchen on the first floor and a restaurant for free workers on the second floor.

- b. Section A₂ produced forgings and castings for the Combine. Old iron was melted down in about three furnaces. 1. There were various kinds of molds, square iron bars about 20 m. long and round iron bars of various

3. Building B also had two sections:

a. Section B₁ was principally a repair shop containing lathes and other machines. [] some kind of smelting process was conducted there.

b. Section B₂ contained a laboratory with chemical equipment. [] various metals were tested there []

4. Building C was an iron rolling mill (prokatnyy tsekh) containing a furnace and several steam hammers. The western end of this building was two-storied and housed offices. It was on the southern side of this building that the model shop was being added.

5. That part of Building D designated as D₁ was a repair shop for locomotives and railroad cars. D₂ of Building D housed offices of the MVD.
